4.0 Sherwood, Washington, Disposal Site

The Sherwood, Washington, Uranium Mill Tailings Radiation Control Act (UMTRCA) Title II Disposal Site was inspected on July 18, 2007, and was in good condition. The tailings impoundment, dam, and diversion channel were in good condition. Forest thinning is continuing adjacent to the site, and reclamation of damaged areas along the site perimeter will occur upon completion of logging activities. The dam inspection and associated piezometer water level measurements verified that the tailings embankment is functioning as designed. Vegetation monitoring continues in an effort to evaluate the effectiveness of biological control of noxious weeds at the site. Groundwater monitoring, performed as a best management practice, showed constituent concentrations were significantly less than State of Washington water quality criteria. No cause for a follow-up inspection was identified.

The site, located near Wellpinit, Washington, was inspected on July 18, 2007. Features and photograph locations (PLs) mentioned in this report are shown on Figure 4–1. Results of the inspection are described below. Numbers in the left margin of this report refer to items s

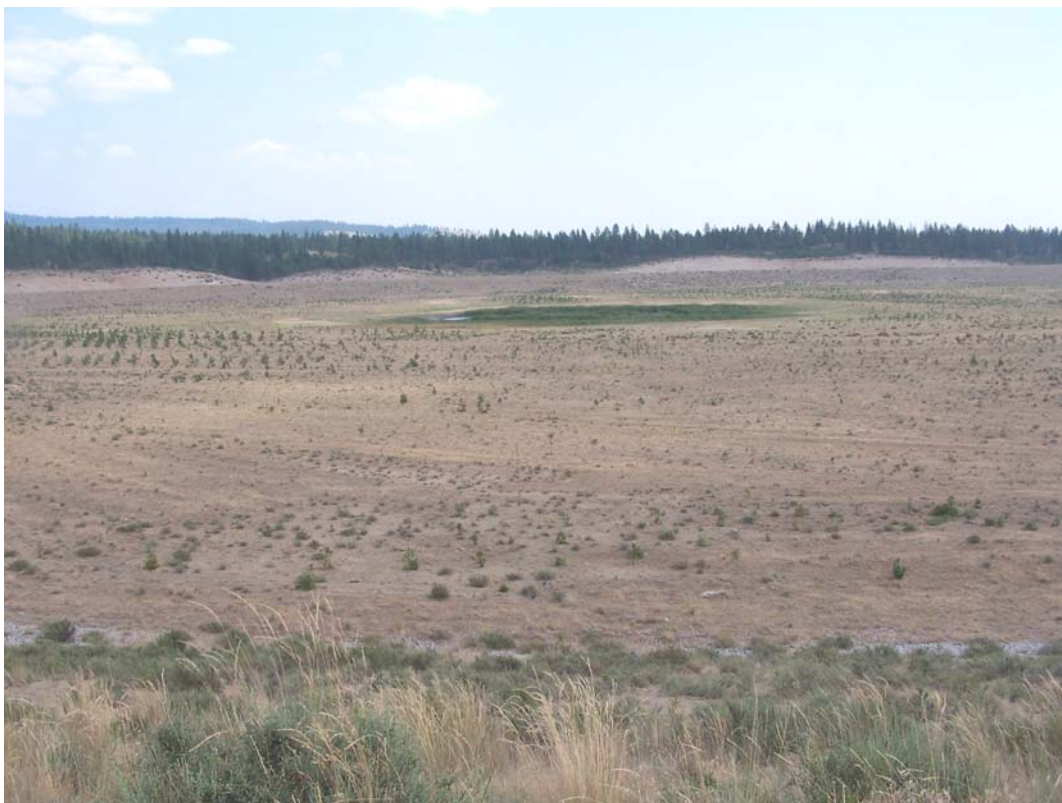
Designers of the cell predicted that some settlement would continue to occur after placement of the uncompacted cover and that it would be self-healing with regard to impacts from freeze-thaw, biointrusion, and settlement (LTSP, page 2–14). The largest area of settlement is now referred to as Pond 1. Some standing water was present in Pond 1 at the time of the inspection, and the plant species present indicate there is year-round moisture below the surface throughout the approximately 7.7-acre pond area (PL–1). Other minor depressions designated as Ponds 2, 3, and 4, with a total area of approximately 2 acres, did not contain standing water. The shallow ponds are considered to be favorable features on the cell top, but DOE will continue to monitor the cover surface for unusual settlement features such as sinkholes or differential displacement to verify cell cover integrity and ensure that the impoundment is performing as designed.

SHE 7/2007. PL-1. Pond 1 on the tailings impoundment.

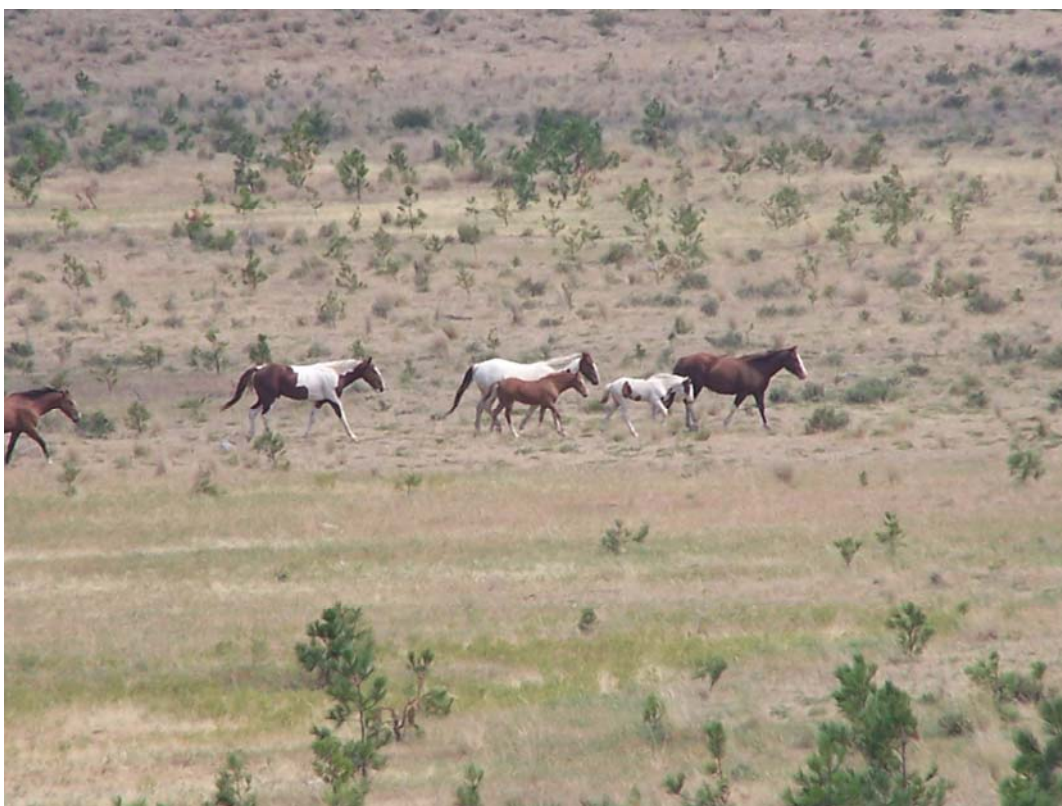
Vegetation in the area of Pond 1 is composed primarily of native wetland species; the other pond areas contain primarily riparian vegetation. The ponds provide habitat for small mammals, birds, amphibians, and reptiles and provide an important water source for larger mammals such as wild horses, deer, elk, bears, and buffalo. Buffalo and horses were on the disposal cell during the time of the inspection (PL–2).

SHE 7/2007. PL-2. Wild horses on the tailings impoundment.

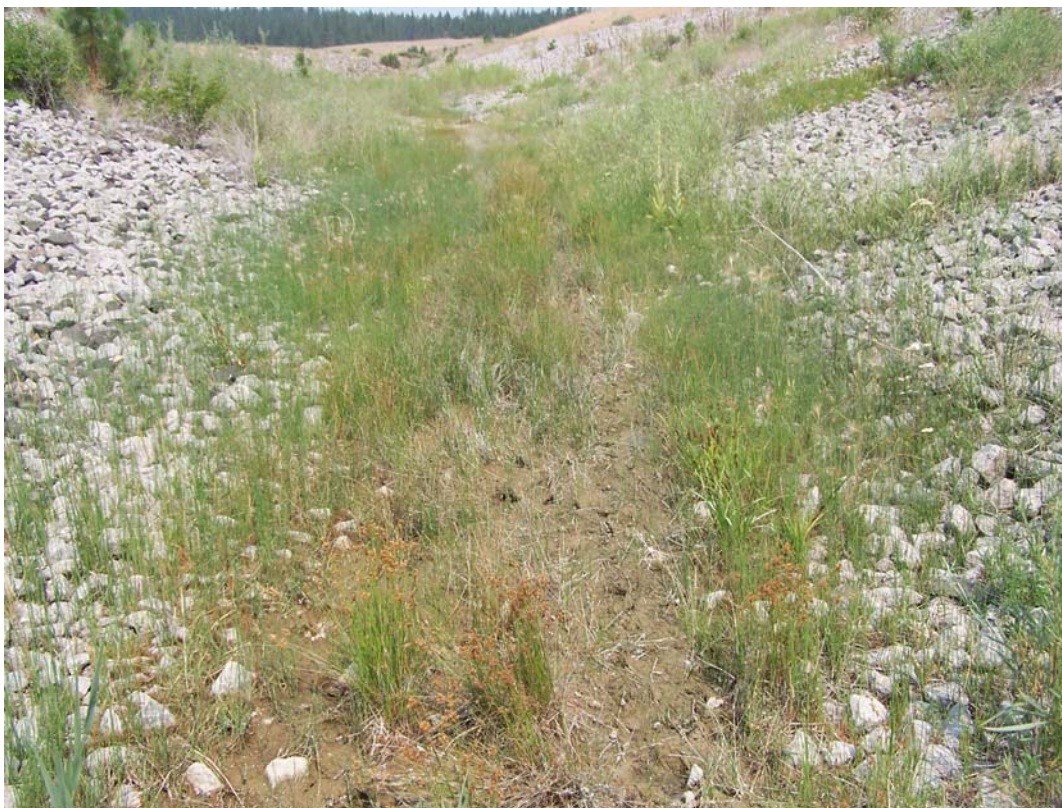
Diversion Channel and Impoundment Dam Face—Inspectors walked the length of the riprap-armored diversion channel. Volunteer plant intrusion within the diversion channel, including trees, is evident in most areas of the channel. The channel was designed to allow trees to grow and stabilize the surfaces, and their presence in the channel is not expected to impact the function of the channel in conveying designed flows. The condition of the riprap cover is good and is the same as that observed during earlier inspections. Sediment deposition is evident in places on the west side of the diversion channel, but does not interfere with the channel's design function; upslope areas that have contributed to the sedimentation are becoming stabilized with vegetation. Two permanent wetland areas have formed along the bottom of the east side of the channel. They provide habitat for a variety of small mammals and birds. In previous years, several pools of standing water have been observed throughout the wetland areas. During the 2007 inspection, only one pool of surface water was present (PL–3). The lack of visible surface water may be indicative of the hotter and drier weather in this area in 2007.

SHE 7/2007. PL-3. Wetland area within the armored diversion channel containing visible surface water.

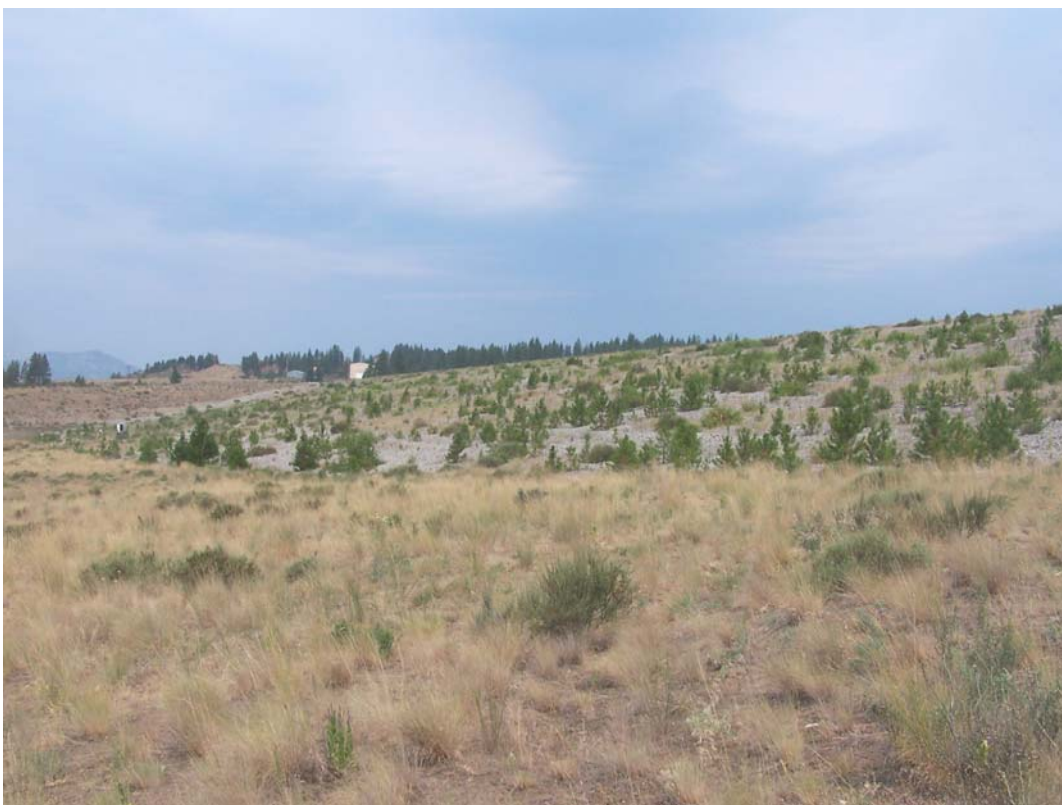
The tailings dam face was designed to allow a vegetative cover, including mature trees, to establish and stabilize the surface and prevent erosion. Consequently, the presence of this vegetation does not negatively affect the function of the dam, and the dam will not be compromised if the rock cover eventually degrades. To out-compete undesirable weeds that were establishing on the face of the dam, seeding with desirable species occurred in fall 2004. Extensive vegetative cover, including Ponderosa pine trees ranging in size from seedlings to 15 feet tall, was observed on the dam face (PL-4). Many seeded species also were observed.

SHE 7/2007. PL-4. Vegetation on the face of the tailings dam.

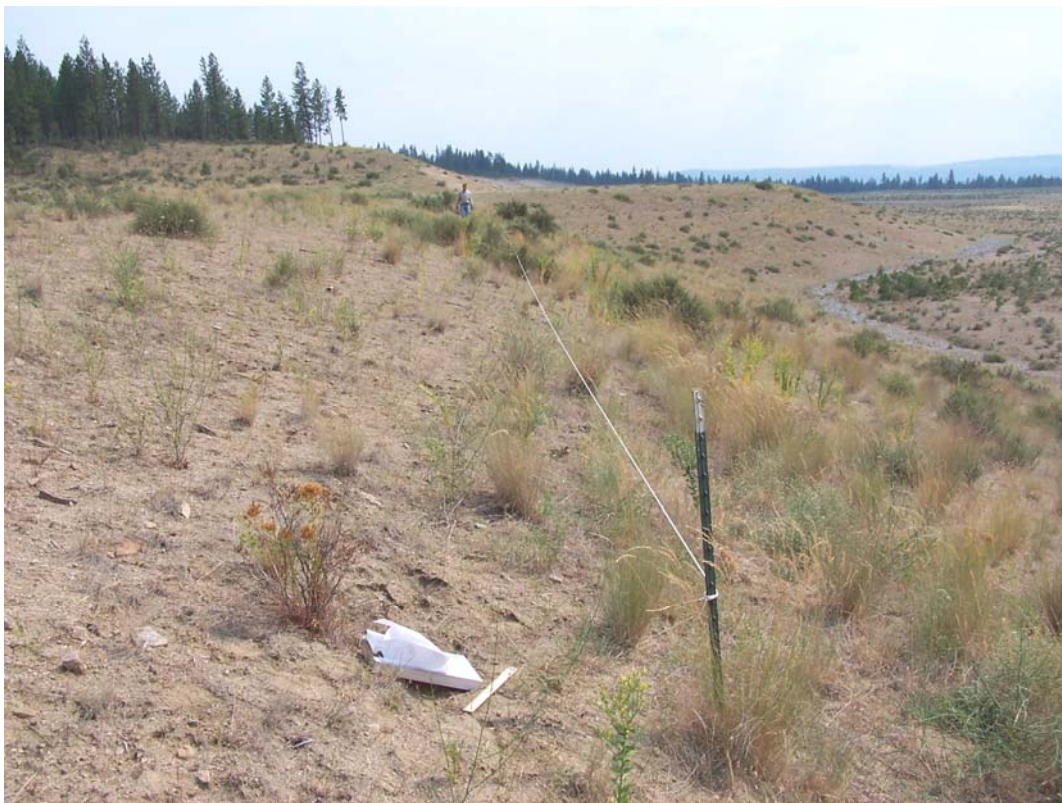
- 4D To monitor the progress of the biological weed control efforts, inspectors counted live noxious weeds along ten permanent weed-monitoring transects established during the 2004 inspection (PL-5). The *Methodology for Conducting Annual Monitoring of Noxious Weeds at the Sherwood, Washington, Disposal Site* (GJO-2004-553-TAC, January 2004) describes the monitoring procedure.

In contrast, the number of dalmatian toadflax plants along the transects steadily increased or stayed about the same from 2004 through 2006. In 2007, however, decreases in plant numbers were observed at transects WM-2, WM-4, WM-6, WM-7, and WM-10, although increases were observed at transects WM-5 and WM-8. Throughout the site, inspectors noted that most dalmatian toadflax plants were visibly stressed, as indicated by the yellow color of the plants' leaves and stalks. This stressed condition was caused either by the released insects or recent drought. Also, the dalmatian toadflax plants appeared to be smaller throughout the site, with mostly immature plants at transects WM-7 and WM-8. The lack of maturation may have been indicative of the drier and hotter weather this year or a result of insect damage. A period of 5 to 7 years is typically needed before significant changes in dalmatian toadflax populations occur.

SHE 7/2007. PL-5. Weed monitoring transect WM-5.

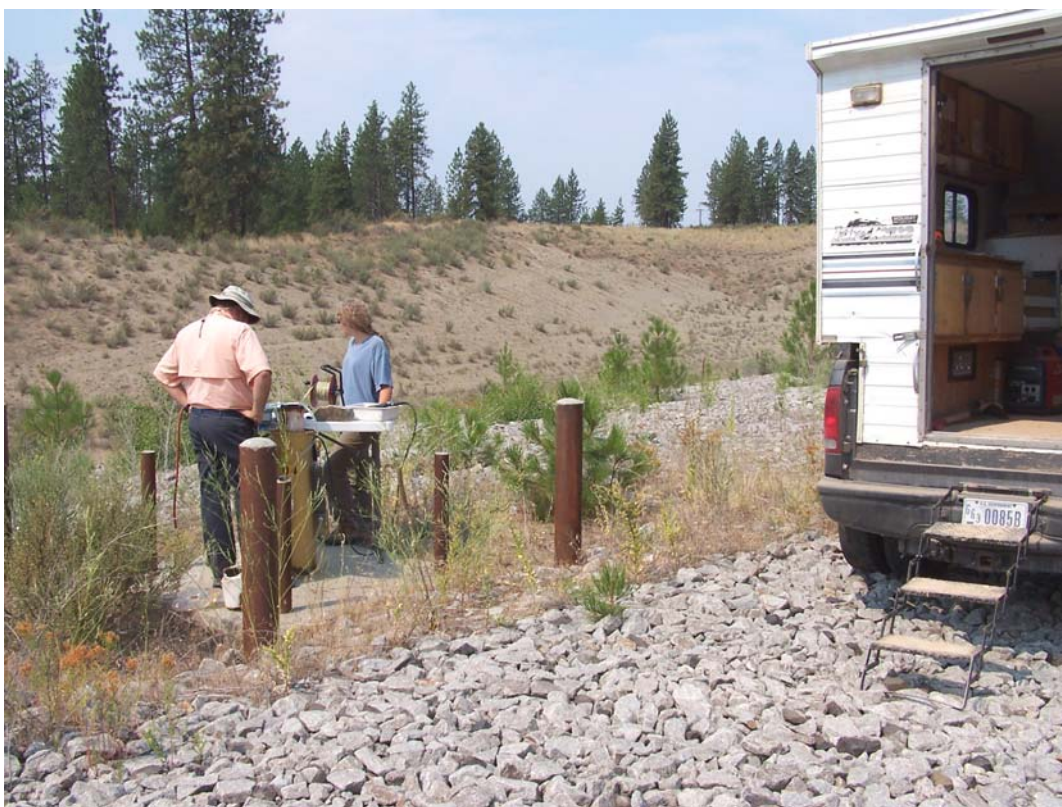
Groundwater sampling was conducted on the same day as the inspection (PL-6), and the results are presented in Table 4-2. Groundwater constituent concentrations were consistent with previous years and continue to be significantly less than the action levels for confirmatory sampling.

SHE 7/2007. PL-6. Groundwater samplers at monitor well MW-4.
